WATERFORD, CONNECTICUT
MILLER POND DAM
00154

PHASE I INSPECTION REPORT
NATIONAL DAM INSPECTION PROGRAM

AUGUST 1980

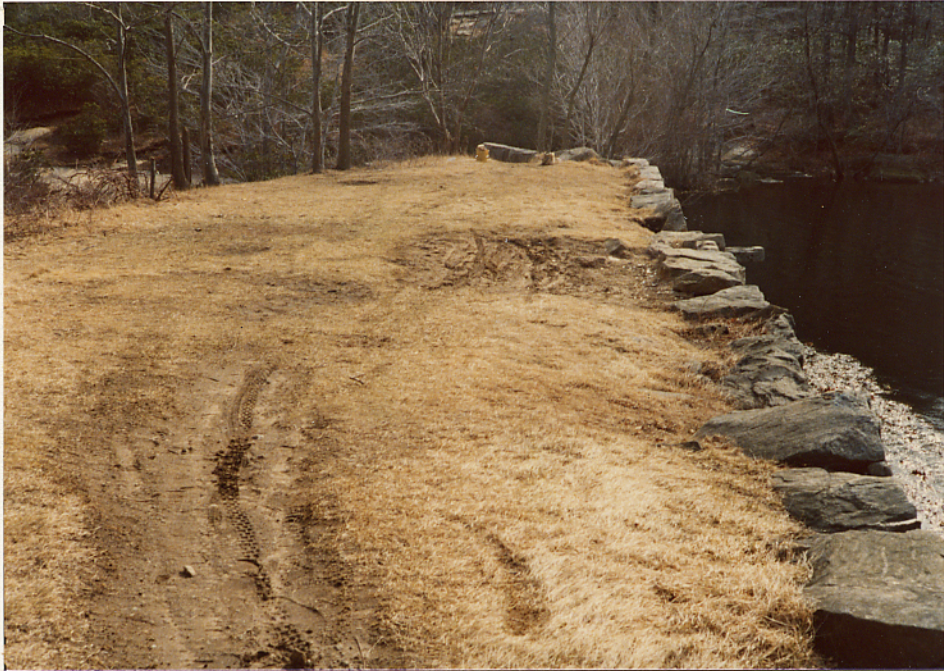
Top of Dam - The top of the embankment is grass covered with a heavy growth of brush and large trees. Towards the right end of the top of the dam, adjacent to the spillway, an eroded area approximately 6 feet by 6 feet and 6 inches in depth was noted (Photo 1). From this area, erosion of the earthfill extends to the spillway along the upstream masonry wall, which is severely damaged and displaced.

Photo 1 - Crest of dam. Note erosion on crest and displacement of masonry on upstream face. (3/20/80).

5. Eroded areas of the earthfill dam crest should be filled with suitable soils, compacted and seeded.
6. The damaged masonry of the upstream training walls of the high-level outlet should be repaired.

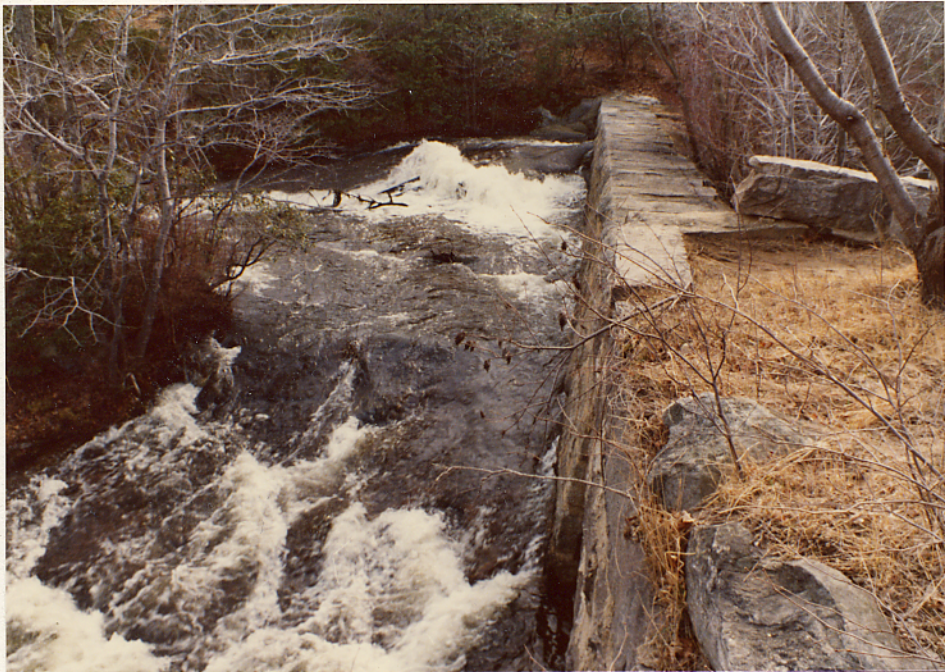
Spillway - The masonry spillway crest is in good condition. No visible cracks or deteriorated zones were observed on the crest (Photo 2). Substantial tree growth and wood debris were noted on the upstream slope of the spillway (Photo 4). The downstream face had some cracking in the mortar joints and several seeps, with a total flow of approximately 3 gpm, in the area of the high-level outlet.

The spillway discharge channel is of exposed bedrock and does not have distinct limits. Approximately one-half of the spillway discharge was running along the toe of the spillway and dam with high velocities, and could cause erosion or undermining along the toe.

2. Constant high velocity flow through the high-level outlet may be causing erosion of its upstream training walls.
3. The high velocity flow running along the downstream toe of the spillway and the dam could lead to deterioration and undermining of the masonry at the toe.

Photo 2 - Spillway crest and discharge channel. Note high velocity flow along toe of dam (3/20/80).

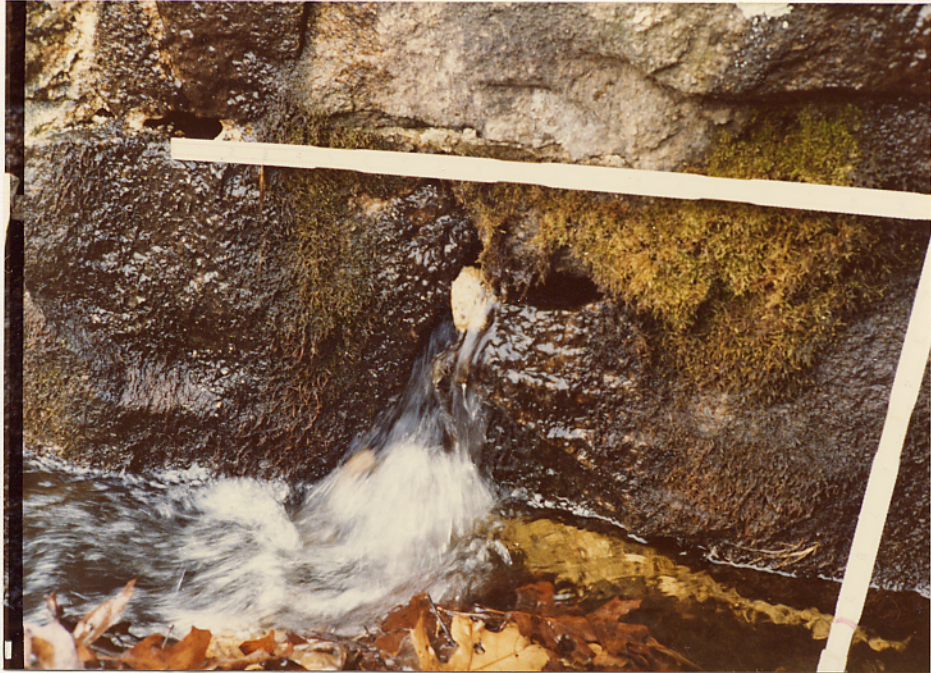
Downstream Face - There is extensive seepage and a large wet area near the toe of the downstream face at a distance of approximately 50 feet to the left of the low-level outlet. The seepage was flowing both through the masonry joints and probably from the base of the dam. The general seepage flow rate in this zone was about 30 gallons per minute (gpm), or more, with separate leaks of up to 10 gpm (Photo 3). In this area, many mortar joints were cracked and leached. The toe of the dam is covered by heavy brush and large trees. One wet area was encountered at a higher elevation than the area described above and had a flow rate at about 1 gpm.

1. Significant seepage through the foundation and the masonry, accompanied by leaching of the cement mortar joints, could weaken the masonry and create stability problems.

Photo 3 - One of several seeps located approximately 50 feet to the left of the low-level outlet (3/20/80).

6. Determination of the origin and significance of seepage at the downstream face and the toe of the dam and, if necessary, development of a boring program to determine the condition of the masonry of the dam and spillway and foundation conditions.
7. Based upon the findings of item 6, above, a program to monitor or eliminate seepage through the dam, spillway and foundation should be developed.
8. Repair of the leached and open mortar joints on the masonry of the upstream and downstream faces of the dam and spillway.

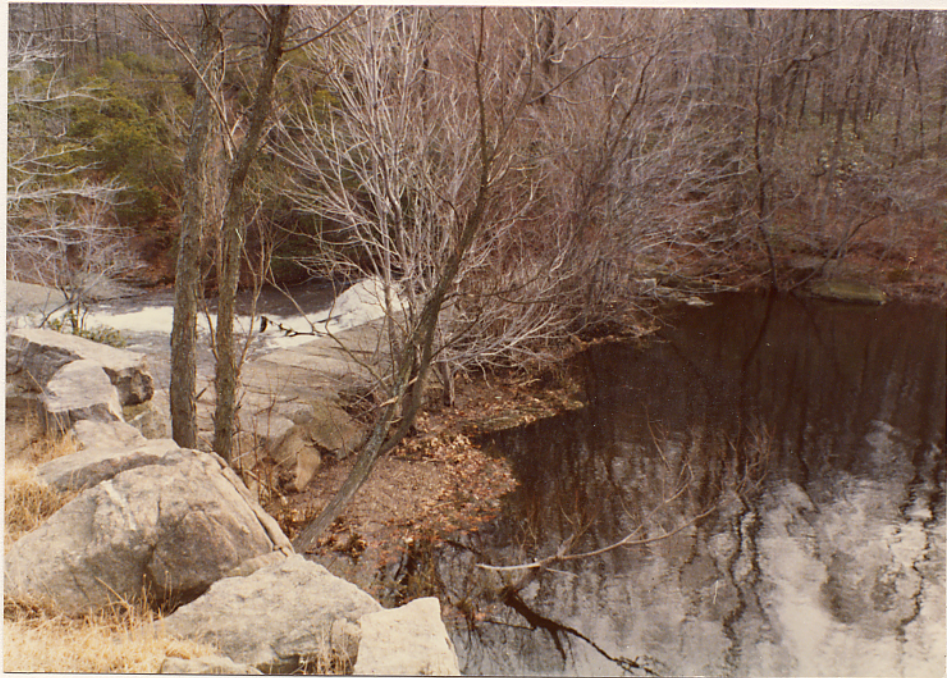
4. The lack of an operable mechanism for the sluice gate does not permit use of the low-level outlet in emergency situations.
5. The trees growing on the crest and masonry faces of the dam and on the upstream slope of the spillway can cause weakness of the masonry and additional seepage by penetration of tree roots.

Photo 4 - Upstream slope of spillway (3/20/80).

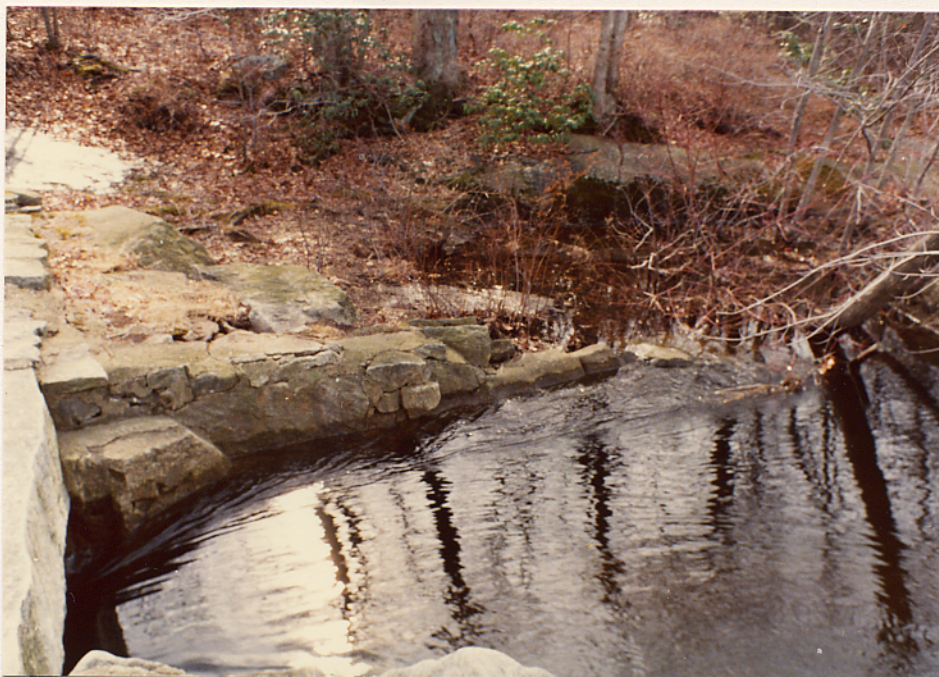
No visible deterioration of the almost submerged high-level spillway outlet was noted. The upstream stone training walls of the outlet are damaged, with partially displaced and fallen stones (Photo 5).

Photo 5 - Deteriorated right training wall of high-level outlet at right end of spillway (3/20/80).

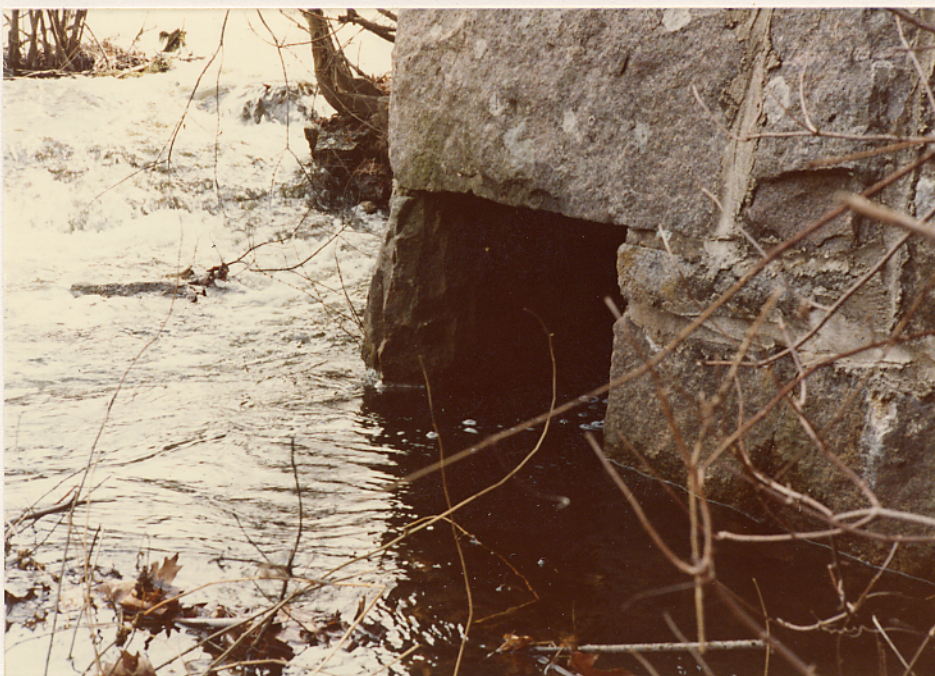
c. Appurtenant Structures - The sluice gate stem of the low-level outlet culvert through the earthfill masonry dam is broken and the sluice gate, presently in a closed position, is not operable. However, a considerable flow (approximately 30 gpm) through the culvert, was observed at its outlet (Photo 6). Most of the flow observed at the outlet is entering the culvert from the surrounding body of the dam.

Photo 6 - Downstream end of low-level outlet culvert (3/20/80).
